Manhole Inspection Summary

Manhole # S33QQ_034MH

Insp Date: **3/23/07 10:20 AM**

Location Address: **2530 MARYLAND ST**

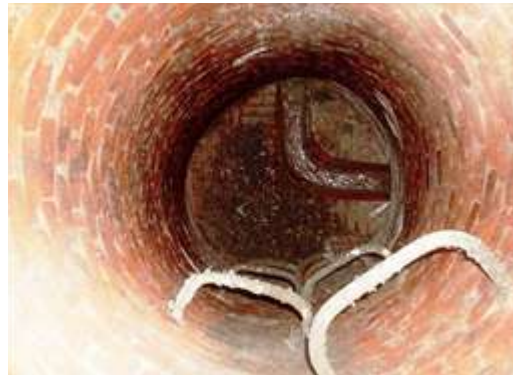
Top View

Corroded steps. Evidence of surcharge - Bench debris.

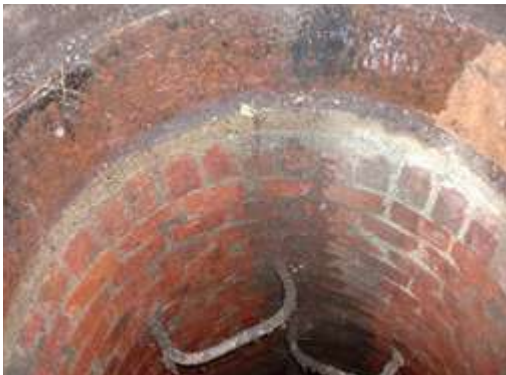
Defect

Frame leaks. Adjustment infiltration.

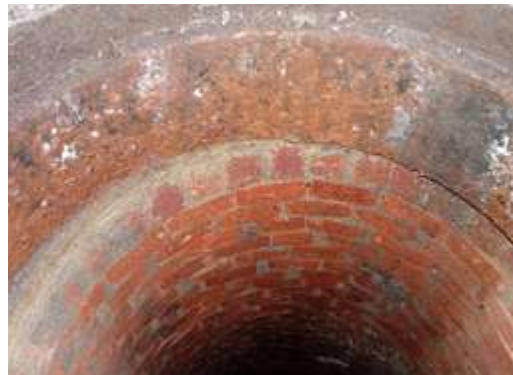
Defect

Frame leaks. Adjustment infiltration.

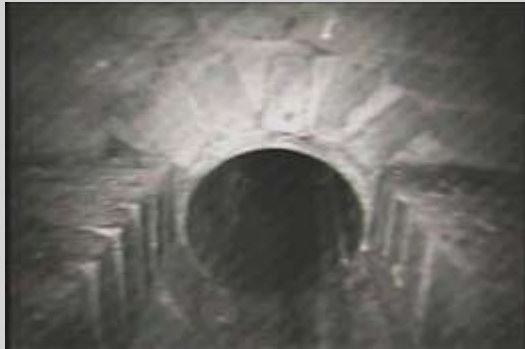
8 in. Circular Gravity Sewer Pipe Out @ 12 O'Clock

Deposits: ☐ None ☐ Mud ☐ Sludge ☐ Debris ☒ Grease

Infiltration: **Evidence** Pipe Seal Cond: **Unknown**

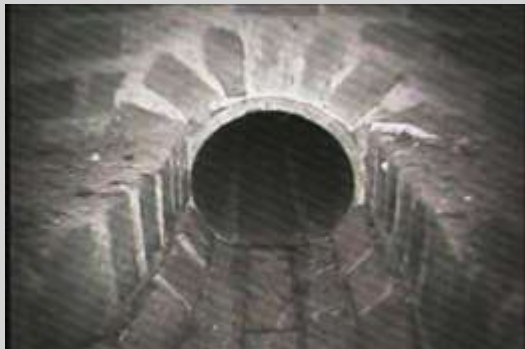
8 in. Circular Gravity Sewer Pipe In @ 3 O'Clock

Bench deterioration.
